Spreader Rebuild Revolved Around A Cam

Pasture-Ready Turkey Feeder

Bin Drying System Improves Grain Quality

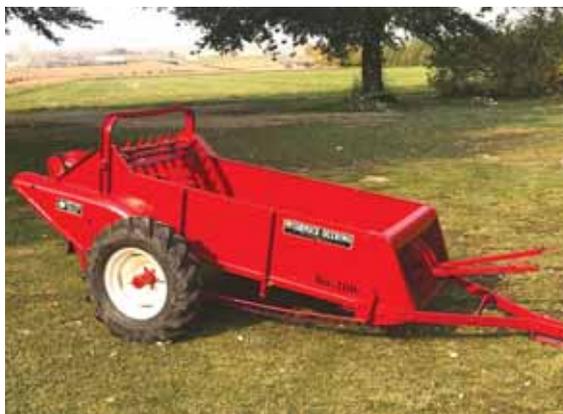
Lar Voss rebuilt this 70-year-old McCormick Deering 100 ground-driven manure spreader, even building a new cam to replace the broken one on the spreader.

"Welding mild steel to the old cast iron hub can probably be done by the experts," says Voss. "A simpler and more lasting solution appeared to be to saw off the part that was broken and replace it with a new cam, which is what we did."

To hold the piece in the saw, Voss machined a 2-in. rod down to 1 3/4 in. He inserted it into

the hub and secured it with various pieces of scrap metal. This allowed him to cut away the broken cam. Setting it on the template made it clear how much material had broken away.

"We cut the new cam out of mild steel and used a mag drill and broach to cut the hole and the keyway," says Voss. "We mounted the new cam in place on the axle, adding spacers to center it on the roller of the lever that indexes the drag chain. It is that action that moves the load to the spreader reels."

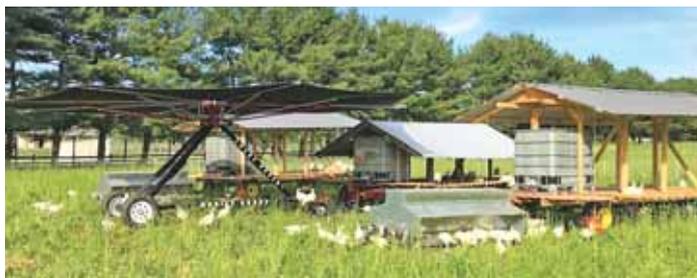
Removable wheels on back allow turkey feeder to be filled by an auger at the feed bin.

Haynes and his co-workers came up with a design they thought would work and built 2 prototypes. The galvanized steel bins are 8 ft. long, 6 ft., 5 in. wide at the top, and 4 ft., 5 in. wide at the bottom. This created an overhang for the 7-in. wide feed troughs. A 3-ft., 5-in. wide lid runs down the center of the bin.

Removable wheels at the rear allow it to be filled with an auger at the feed bin and towed down the road to the pasture. Once in the

pasture, 3 jacks raise the bin up so wheels can be removed and then it's let down on its skids.

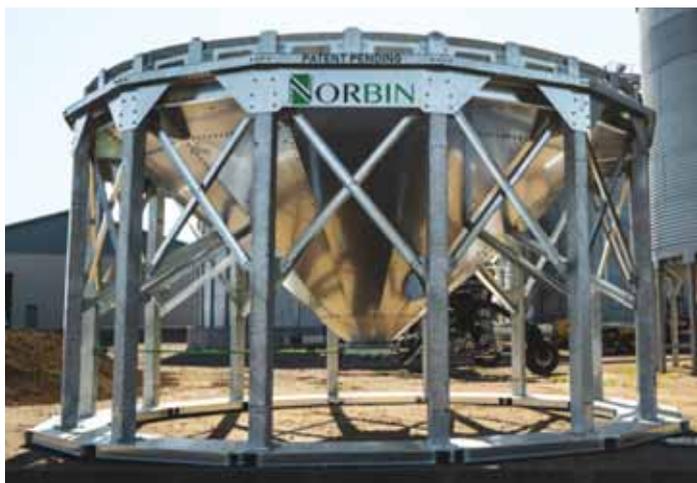
Carefully calculated perforations in hopper cone provide uniform air flow to improve grain quality.

of the grain should be aerated," Frank says. "Anything less can lead to hot spots and spoilage. Our NorBin system provides uniform airflow through a system of carefully calculated perforations throughout the hopper cone. We've had the system thoroughly tested and air flow is uniform throughout the full cone because of our patent pending design," Frank says.
